Rock monuments and historical buildings

Authors: Prof. Dr. habil. Heinz Konietzky & Dr. Jörn Wichert
(TU Bergakademie Freiberg, Geotechnical Institute)

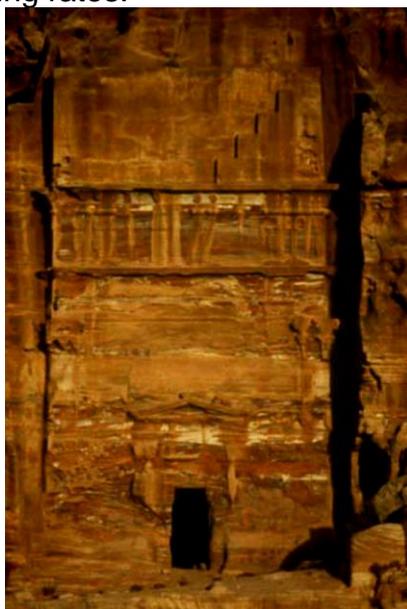
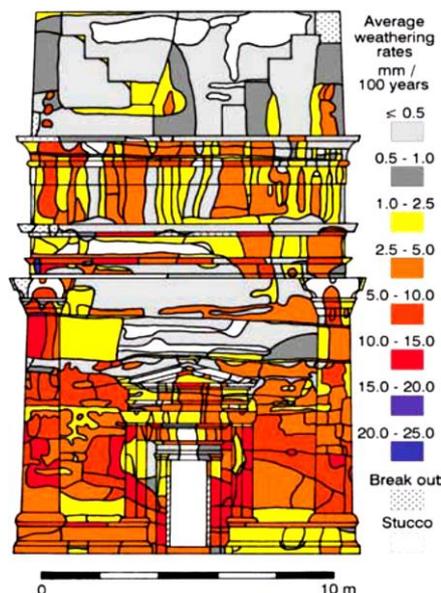
Fig. 1. Average weathering rates of Tomb 778 (Petra, Jordan) (Fitzner, 2004)

Weathering is a time-dependent process like documented in Fig. 1 by average weathering rates.

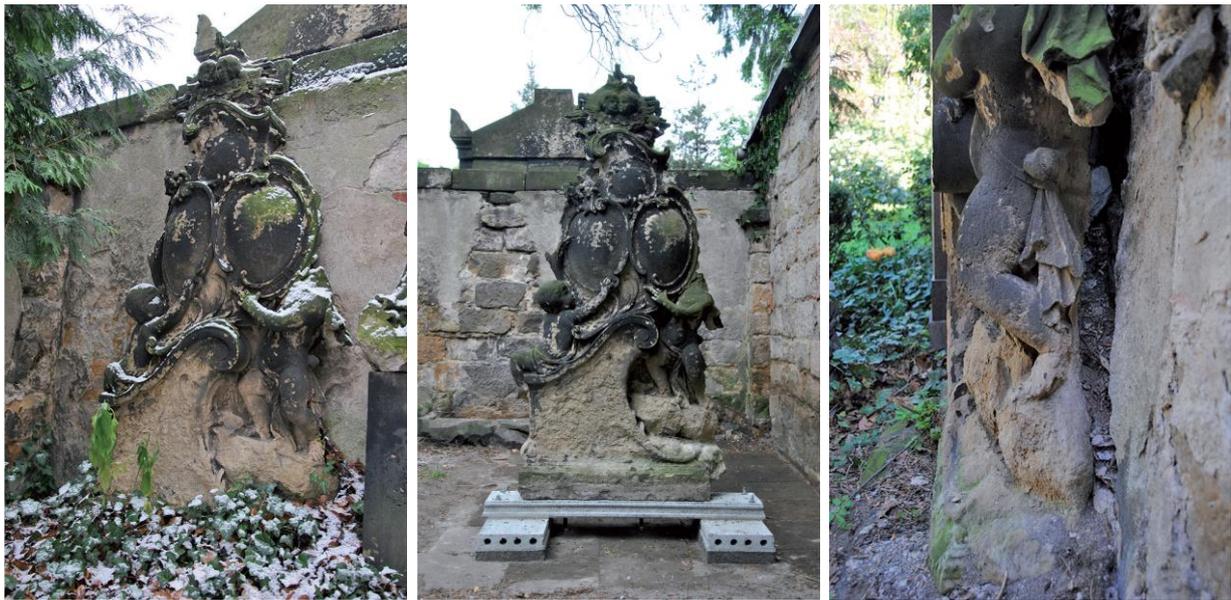
Fig. 2. Weathered baroque sandstone tombstone in Dresden [Wichert et al. 2018]

ICOMOS-ISCS (International Scientific Committee for Stone: ISCS) has introduced a common language to describe degradation pattern (tab. 1). Besides general terms like alteration, damage, decay, degradation, deterioration and weathering this document describes and illustrates the different types of cracks, deformations, detachments, features induced by material loss, discoloration, deposit and biological colonization (see ICOMOS 2008). Fig. 2 and 3 illustrate the procedure on the basis of a baroque tombstone.

The considered baroque tombstone is shown in Fig. 2 and the damage state is characterized according to the ICOMOS classification (see Fig. 3). As Fig. 3 shows, the monument is heavily damaged.

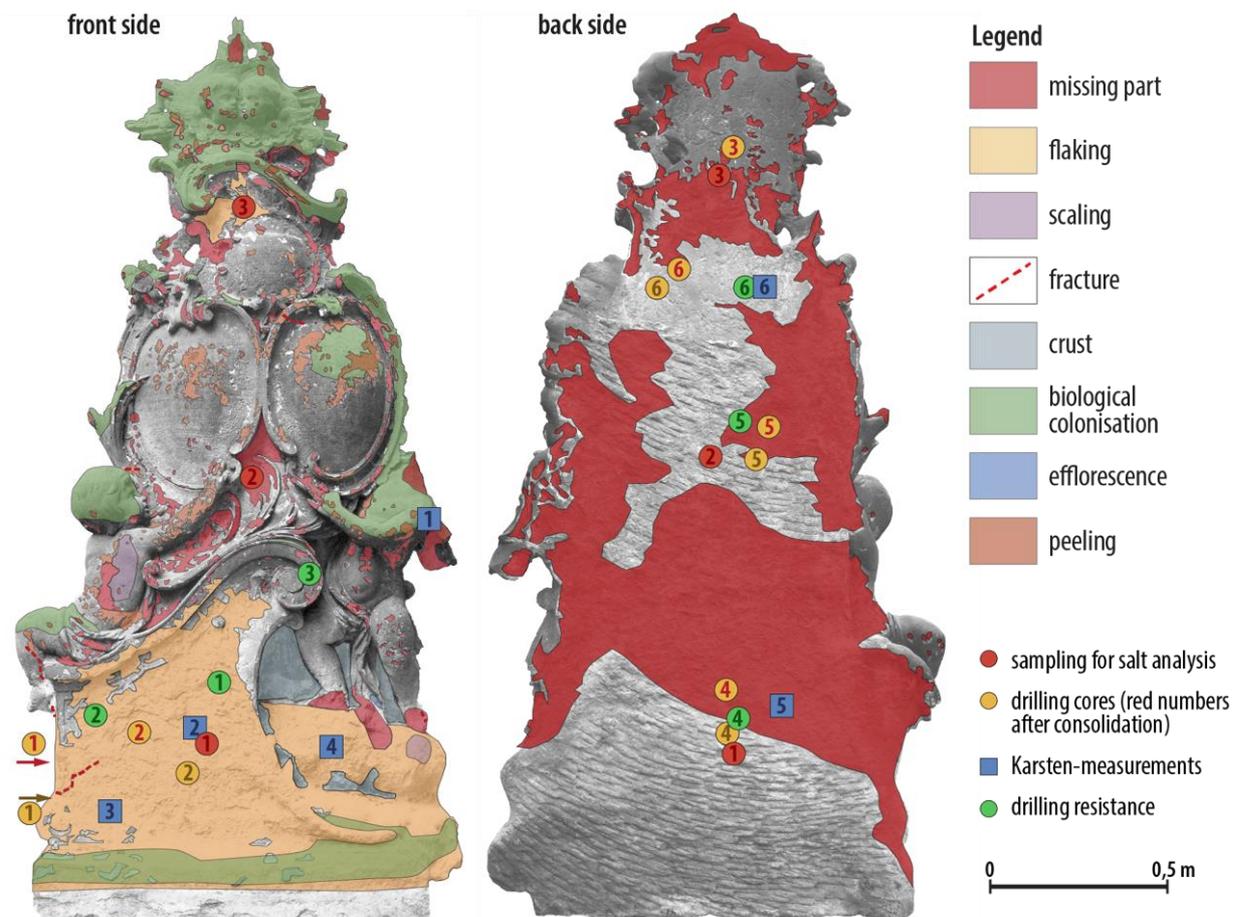
Fig. 3: Damage mapping of baroque tombstone according to the ICOMOS classification [Wichert et al. 2019]

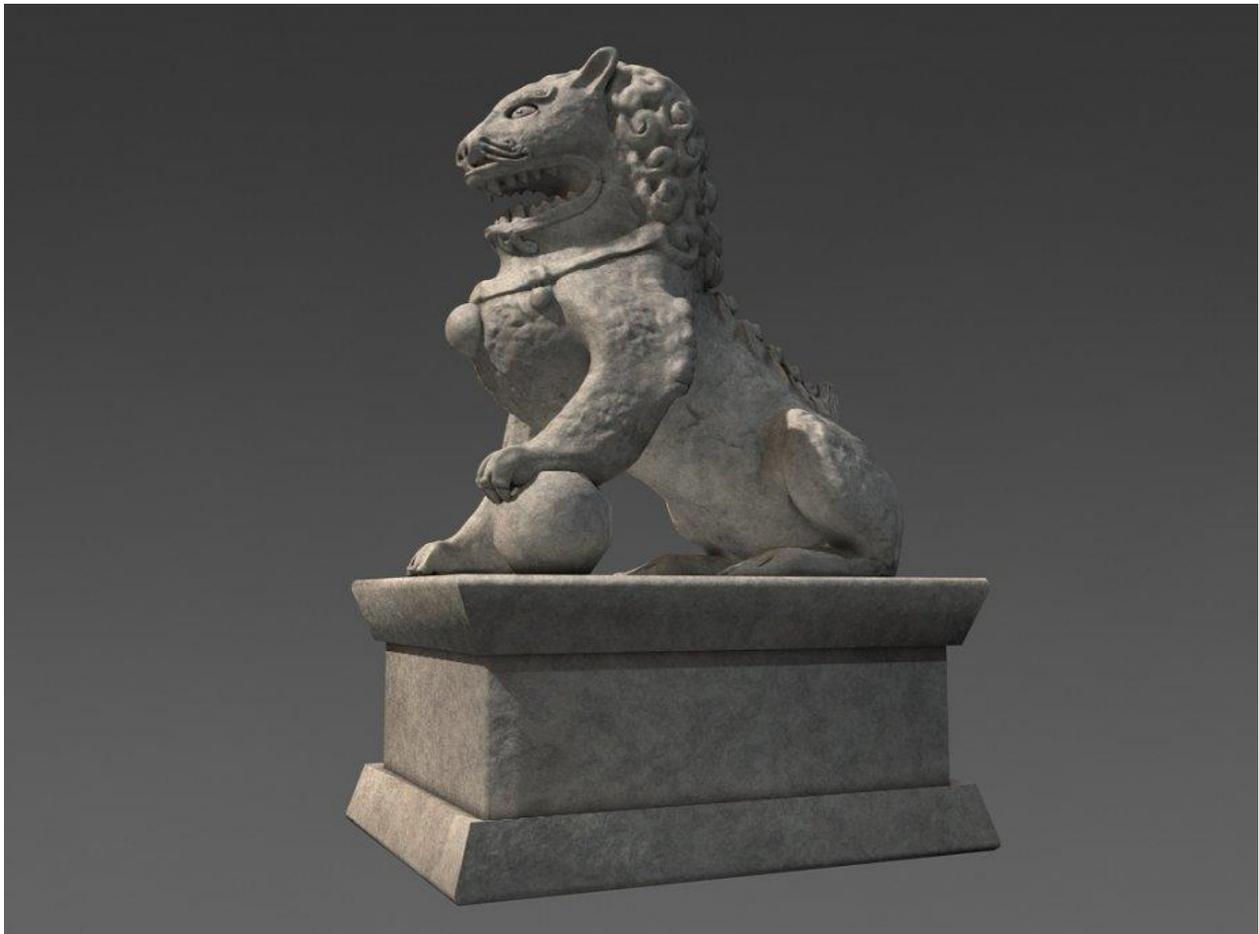
Fig. 4: 3-dimensional DEM of a Chinese rock statue (company material: CG studio, 2016)

Today high-resolution Laser-Scanning (resolution up to 0.01 mm) is available to generate Digital Elevation Models (DEM) like shown in Fig. 4.

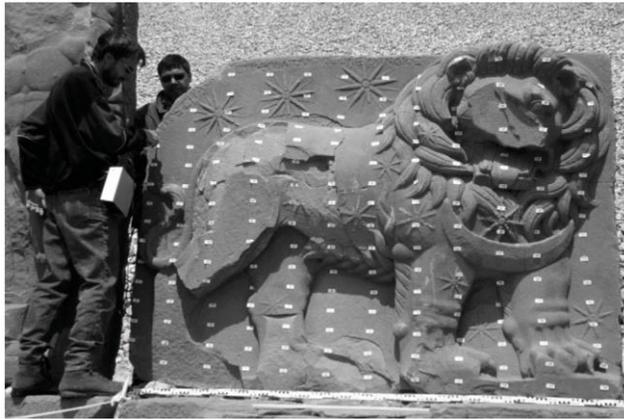
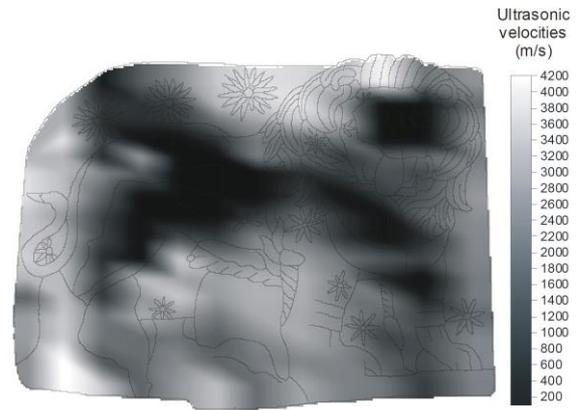
Fig. 5: Ultrasonic P-wave speed measurements (Fitzner, 2004b)

- Ultrasonic wave measurements (> 20 kHz)
 - Based on determination of wave speed and/or attenuation of waves
 - Serves to determine the degree of weathering, to estimate the actual strength and to detect fractures

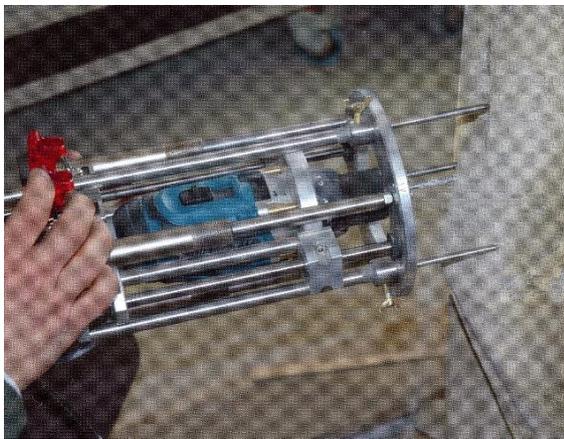
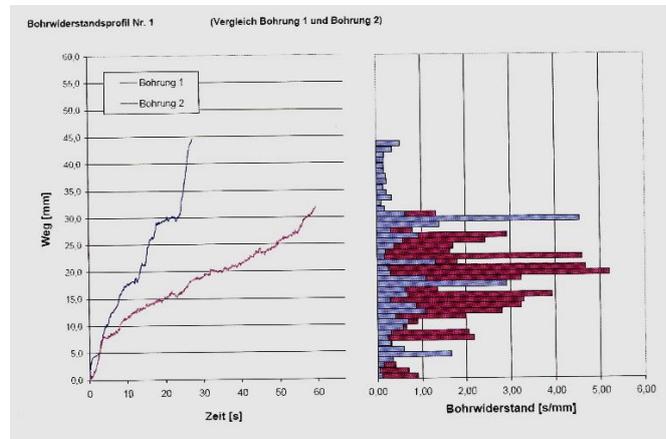
Fig. 6: Drilling resistance measurement (left side, Pummer, 2007). The diagram shows penetration depth (in mm) versus time (in s) for two different boreholes and penetration depth versus drilling resistance (in s/mm) (right side).

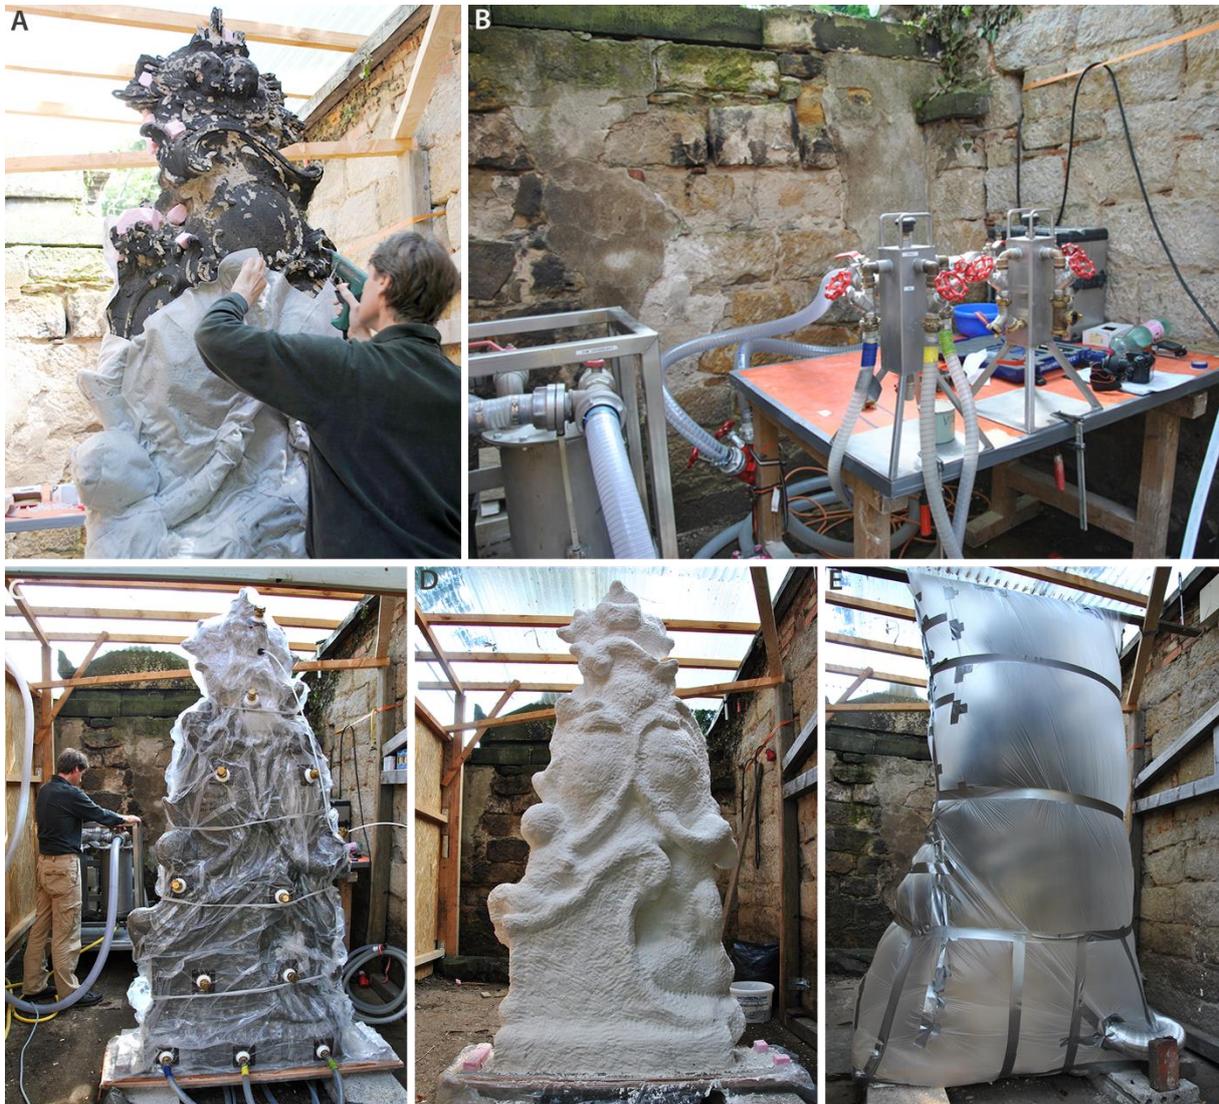
Fig. 7: Desalting measures of a tombstone; A: Protection of the surface by covering with non-woven fabric before covering with the foil; B: Equipment for desalting; C: Desalting of the foil covered tombstone with tubes for water supply; D: Cellulose compress on the wet tombstone shortly after removing the foil; E: Active drying to remove remaining moisture after natural drying (Wichert et al., 2019).

The VCM was applied first for desalting (flushing the tomb with distilled water using under-pressure for a few weeks) and later to consolidate the monument with a special injection material also using the vacuum technique. Fig. 7 illustrates the procedure.

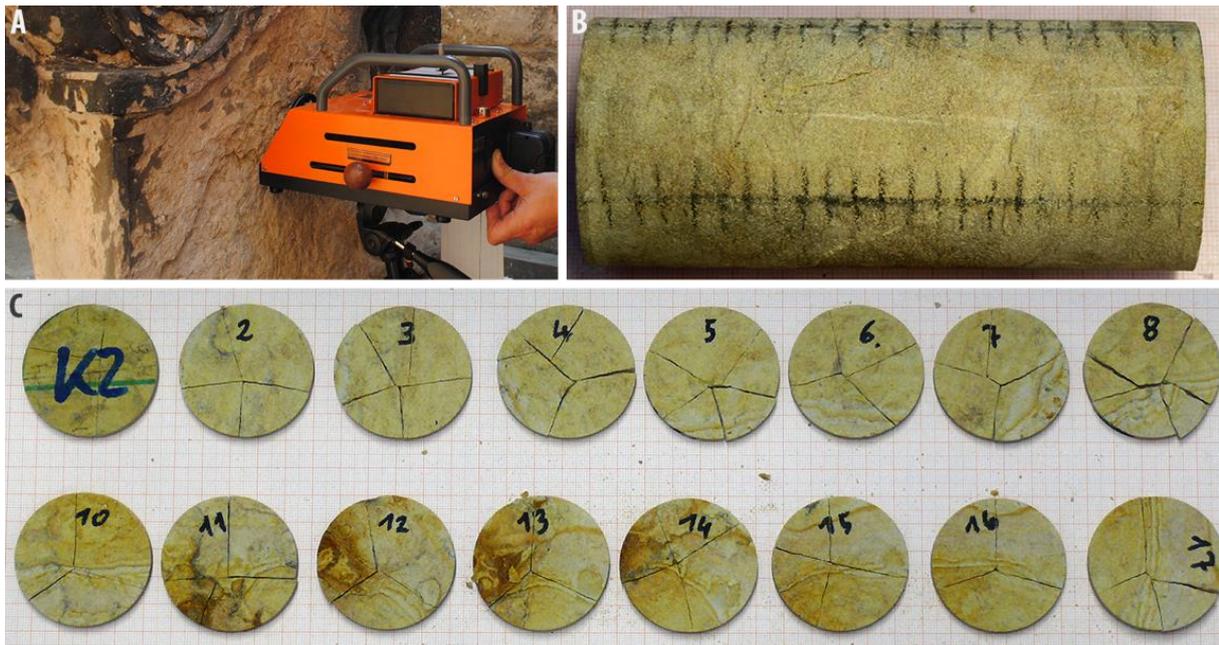
Fig. 8: A: Drilling resistance measurement; B: Core from tombstone with marks for cutting discs; C: Discs with a thickness of 5 mm for the fine scaled determination of the flexural tensile strength and Young's modulus (Wichert et al., 2019).

In parallel some measurements were conducted to quantify the consolidation effect. Cores were drilled from the tombstone and sample cubes for the determination of the standard rock-mechanical parameters. Furthermore, specific methods in conservation science were applied like determination of the drilling resistance (Fig. 8-A), biaxial flexural strength and uniaxial compression tests as well as Brazilian tests on sample discs (Fig. 8-B, C). These tests deliver high resolution information about strength and stiffness. The drilling resistance measurements were carried out by the device DURABO (3 mm diameter driller) with constant rotation speed and constant contact pressure. The reciprocal velocity of penetration n (in s/mm) describes the drilling resistance. The higher the drilling resistance the harder the stone, resulting in a hardness profile which allows a general statement of the stone condition before and after the consolidation.

The determination of the biaxial flexural strength and the Young's modulus of discs allows to obtain a strength and stiffness profile from the surface to the inner part of an object. Normally, a core with a length of 10 cm and a diameter of 5 cm is drilled and cut into 5 mm thick discs. With a specific test equipment and corresponding evaluation formulas it is possible to measure the biaxial flexural strength as well as the Young's modulus as an expression of the deformability of the sample.

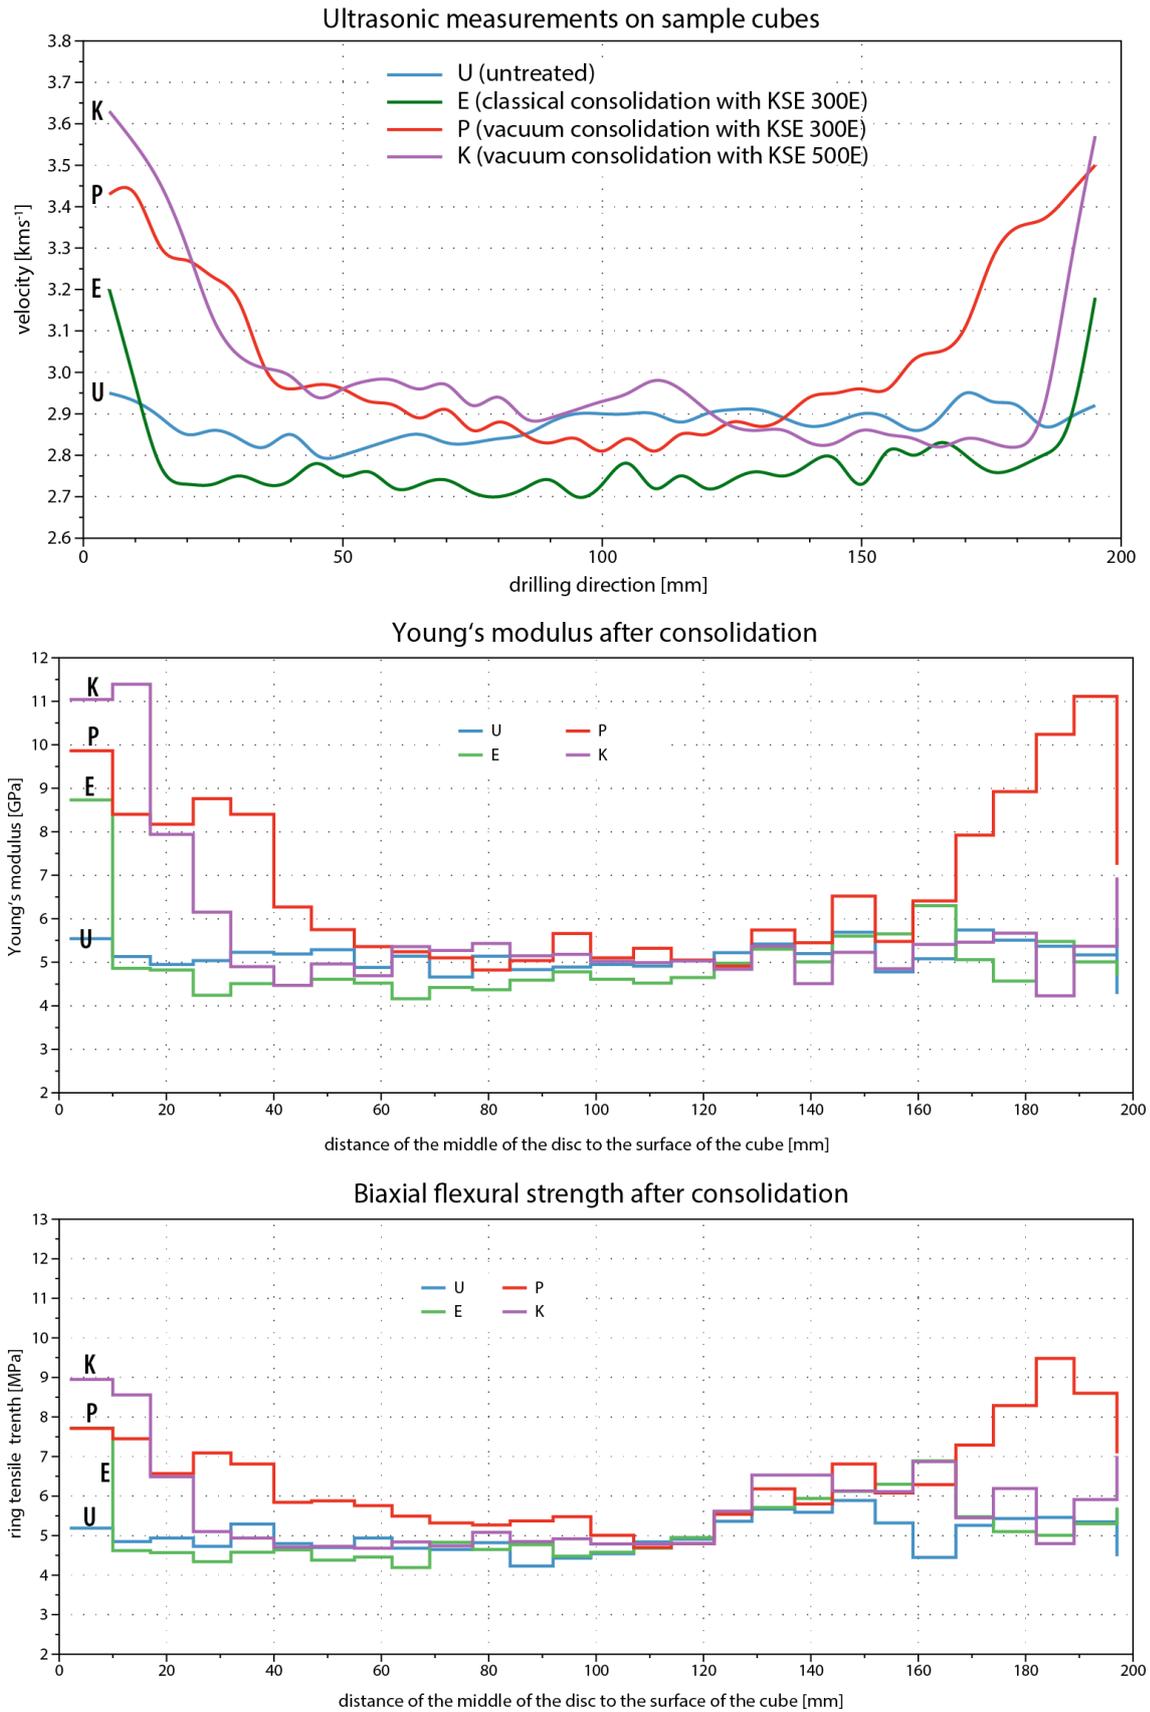
Fig. 9: Charts showing different rock parameters before (U, blue curve) and after different consolidations (E, P, K) of the cubic samples demonstrating the consolidation effect of different degree (Wichert et al., 2019).

By determining the propagation speed of ultrasonic wave pulses of identical, but freshly broken rock material, the effect of different treatments and different consolidants are evaluated. Drill cores obtained from treated cubic samples are used to monitor p-wave-speed orthogonal to the drill core's axis and hence set up a speed-profile in penetration direction of the consolidant (Fig. 9). Since this method is fully non-destructive the results can be compared and related to strength and stiffness profiles obtained by (destructive) biaxial flexural tensile tests on the same drill cores (Fig. 9). The blue line (U) corresponds to the untreated samples. All treatments lead to a strengthening up to a depth of 50 mm. Test results also reveal that there is no local over-strengthening. Vacuum consolidation using the consolidant KSE 300E shows rather smooth strength-depth curves. However, the use of other consolidants or application of the classical consolidation approach led to a more altered surface while rock volume at greater distance from the surface is not apparently strengthened.

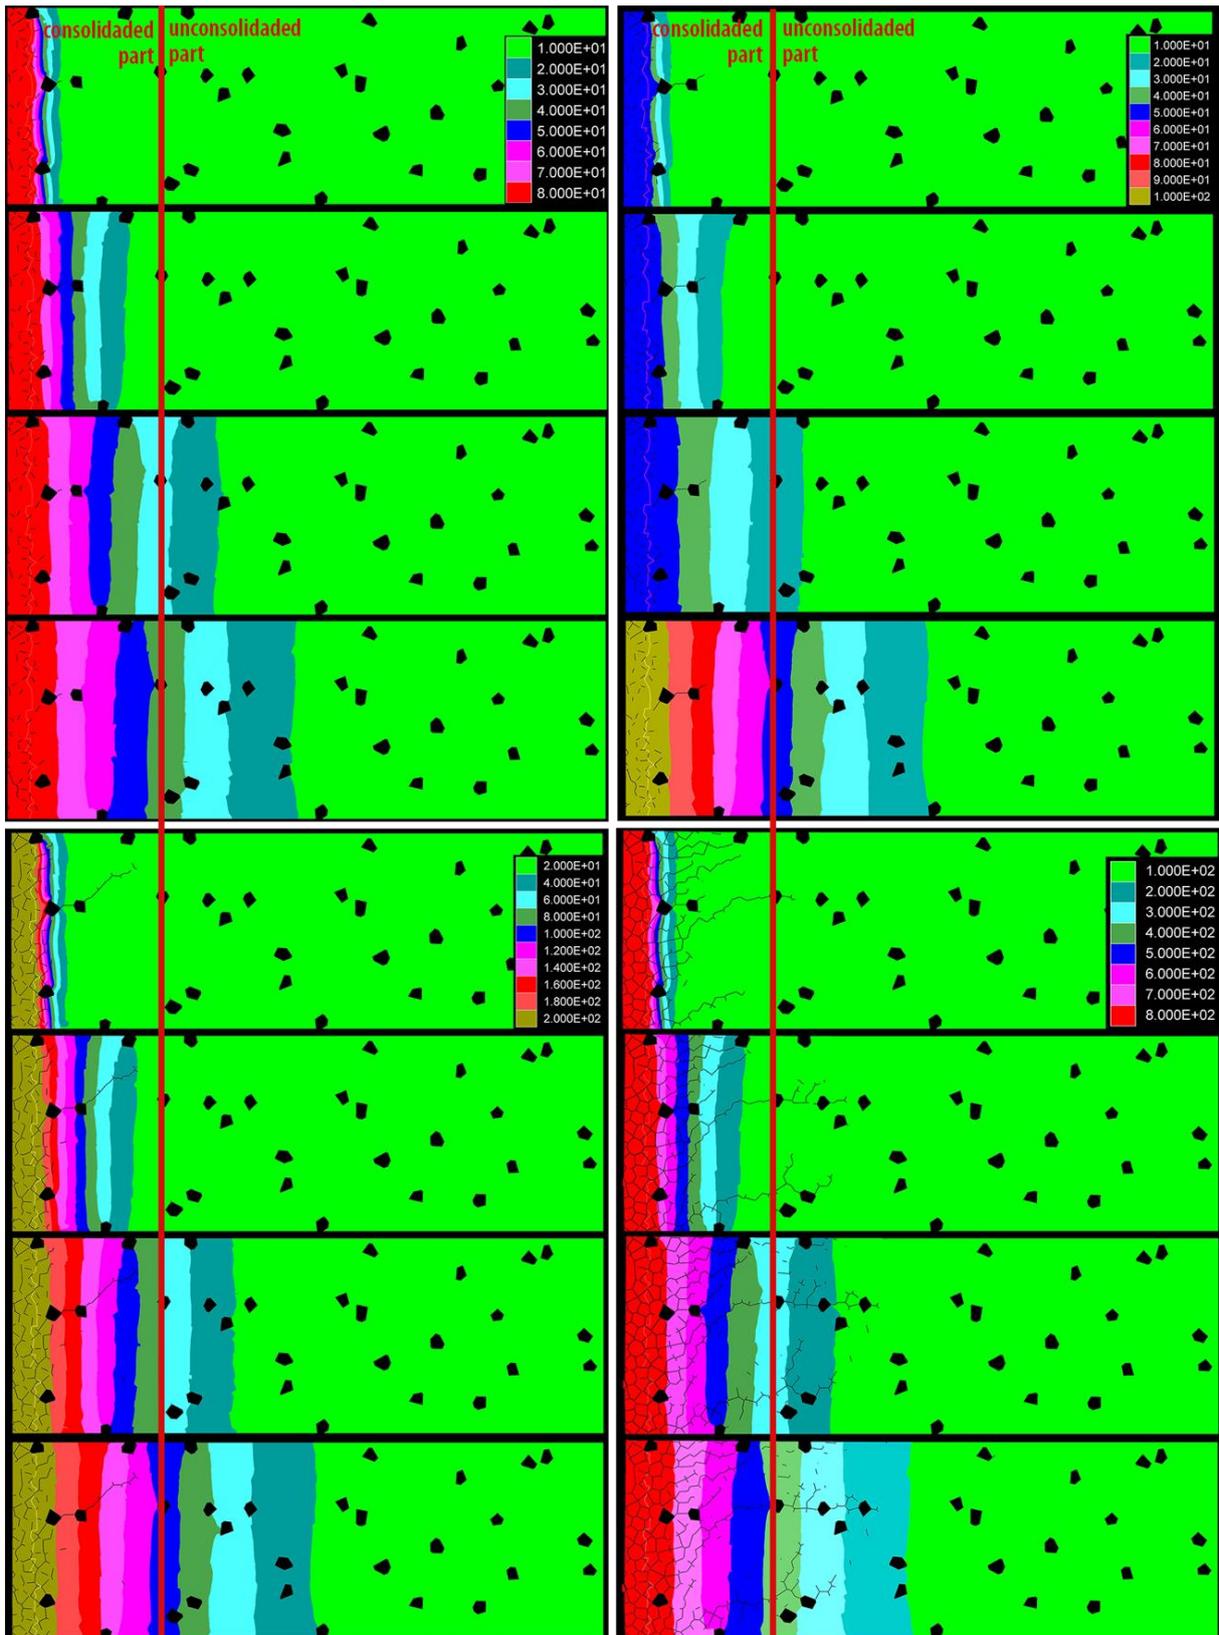
Fig. 10: Crack propagation due to thermal impact with 80 °C (upper left), 100 °C (upper right), 200 °C (lower left) and 800 °C (lower right). The size of the model corresponds to the sample size of 12 cm x 5 cm.

The performed simulations correspond to untreated, treated (consolidated) and untreated-consolidated configurations. The models are mechanically fixed at the lower edge. Afterwards, thermo-mechanical impact by temperature of 0°C, 40°C, 60°C and 80°C were simulated. For the untreated-consolidated state also temperatures of 100°C, 150°C, 200°C and 800°C were simulated. Note, this and even higher temperatures can be reached during fire. During the simulation the higher temperature is assigned on the left model side while 0°C is assigned to the right model side (Fig. 10). Furthermore, the left side corresponds to the consolidated part with a width of 3 cm assuming a total model length of 12 cm.

The thermo-mechanical simulations are carried out stepwise. Firstly, the temperature is increased. Aim is to simulate the stress development depending on the development of the temperature over time. By applying high temperatures cracks are induced, followed by the propagation and coalescence of cracks. Based on different parameters like stress and strain distribution as well as crack development proposals for possible conservation measures can be deduced. Microcracks occur in different quantities, size and distribution. First partial but not continuous cracks develop at a temperature of about 80 °C in all models. The partial crack propagation continues and first continuous cracks develop at a temperature of about 100 °C. Crack development proceeds up to about 200 °C and, as shown in Fig. 10, cracks propagate further into the rock with lower temperature of about 20 °C.

The simulation with maximum temperatures of 800 °C is carried out because fires can reach temperatures of over 1000 °C, although “common fires” reach only lower temperatures. In these simulations massive crack propagation develops already after a few seconds. Please note, that the special phenomena of α - β -transition of quartz is not considered.

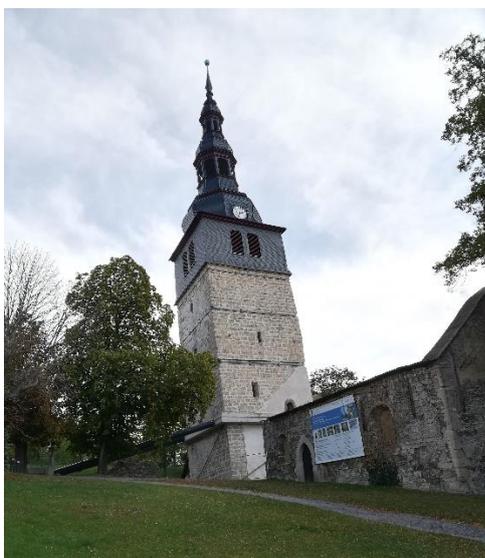
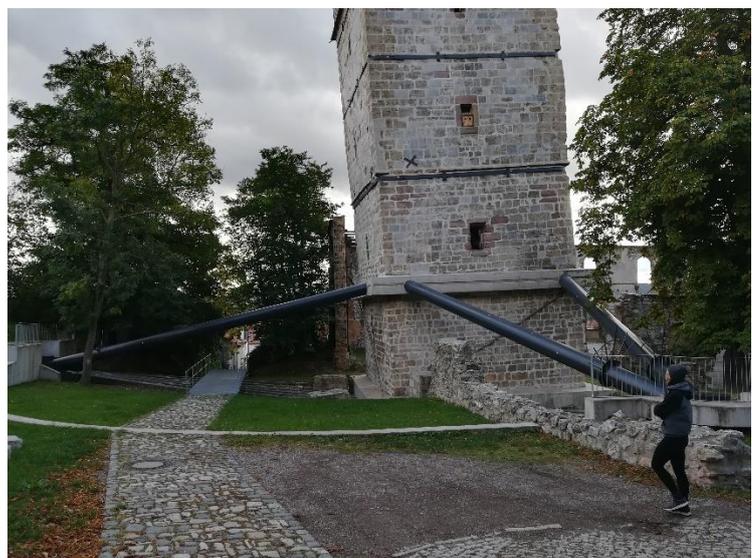
Fig. 11: Leaning tower of Bad Frankenhausen (Germany)

The leaning tower of Bad Frankenhausen (Germany) is an interesting example, which shows the application of a special retaining structure to stabilize the tower (part of an old church). The inclination of the 56 m high tower is 4.7° (4.6 m away from the perpendicular). The inclination is caused by an ongoing underground solution processes due to the existence of salt-bearing rock layers in contact with groundwater (Fig. 11 and 12):

- 1920: 2,21 m
- 1960: 3,60 m
- 2001: 3,89 m
- 2007: 4,41 m
- 2013: 4,60 m

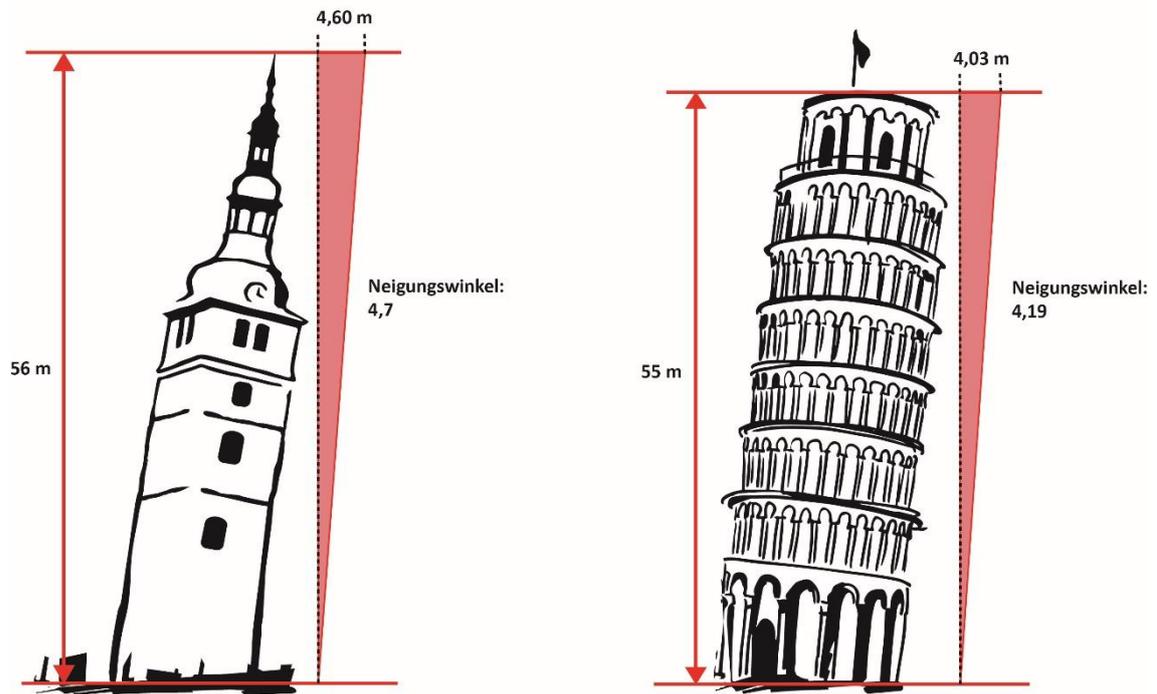
Fig. 12: Comparison between Leaning Tower of Bad Frankenhausen and Pisa (www.der-schiefe-turm.de)

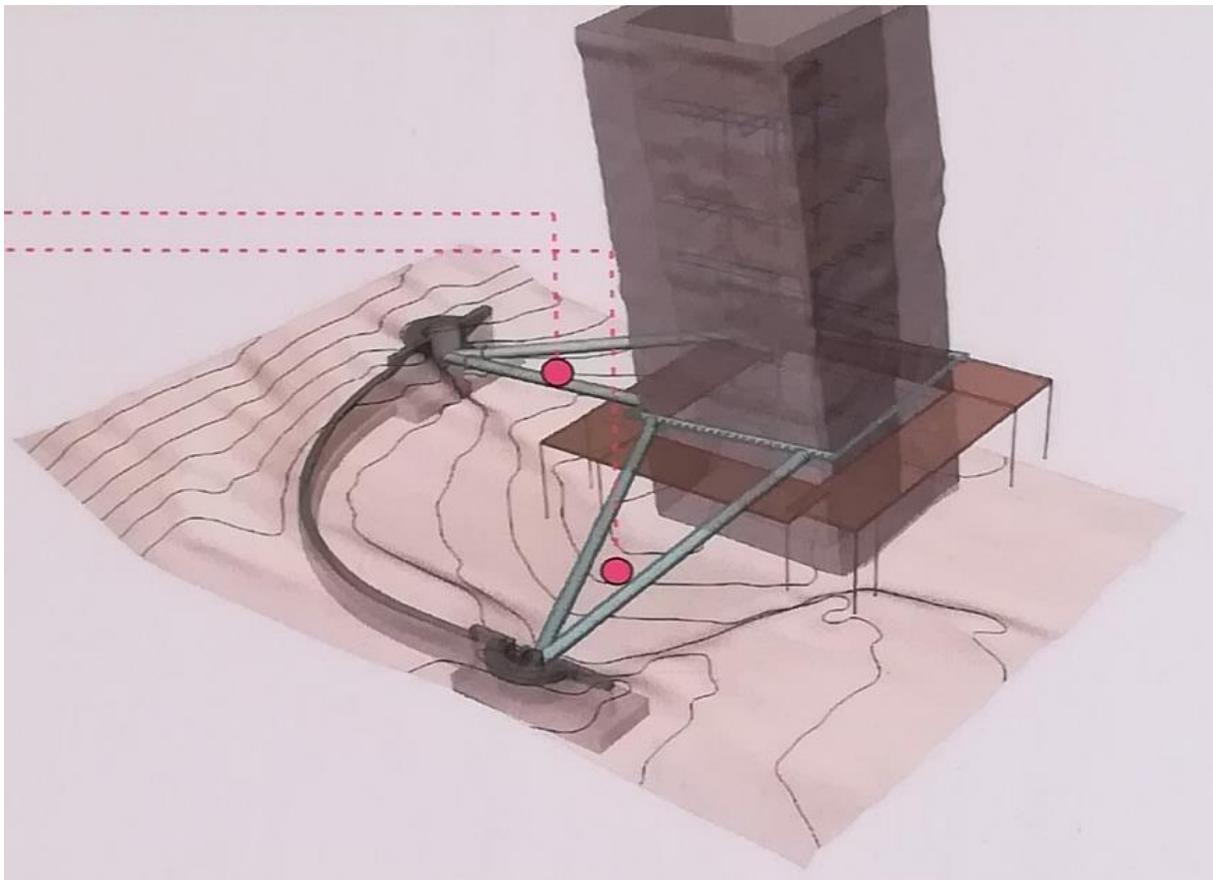
Fig. 13: Retaining structure to stabilize the leaning tower of Bad Frankenhausen

The whole stabilization consists of several elements: injections up to 8 m deep to improve load bearing capacity and a retaining structure with 14 and 16 m long steel struts connected with a retaining wall (see Fig. 13).

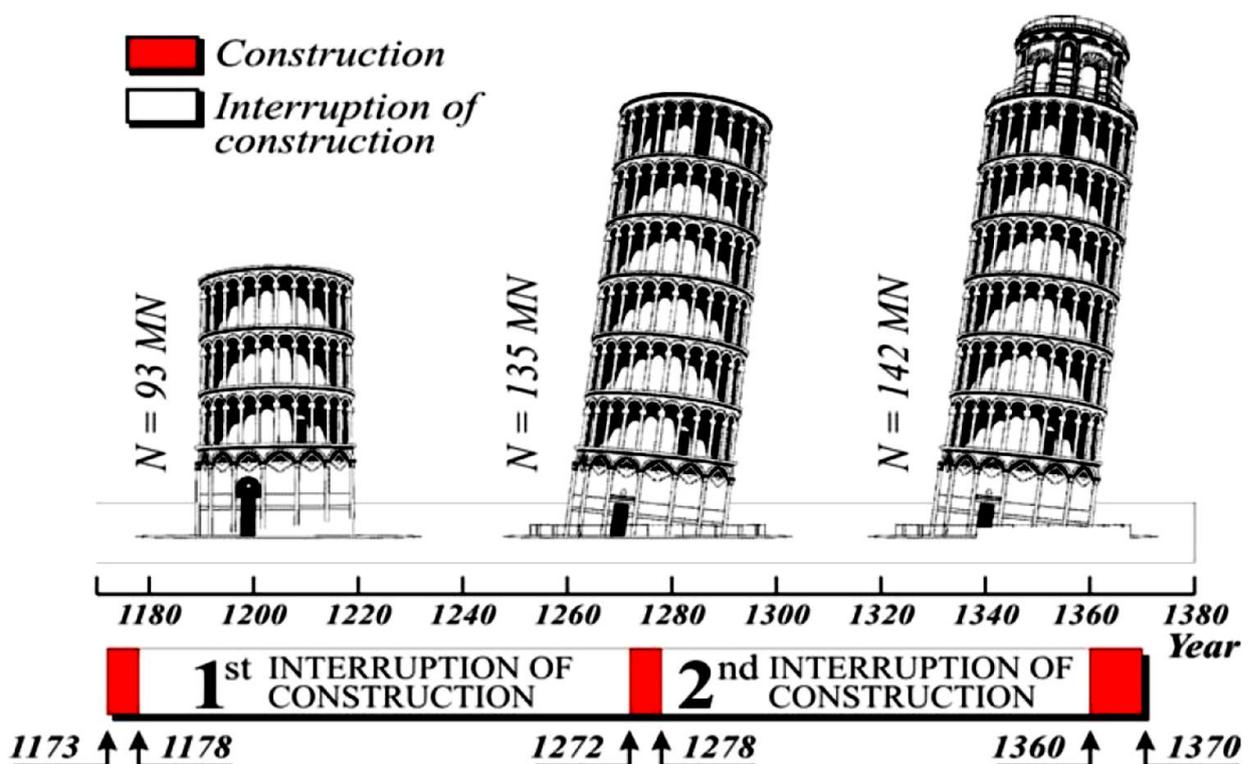
Fig. 14: Evolution of inclination in relation to construction stage and time (Burland et al. 2009)

Another example is the well-known Leaning Tower of Pisa (Burland et al. 2009, 2015). The evolution of inclination is documented in Fig. 14. The geological profile of the foundation region is documented in Fig. 15. The inclination process of the tower is governed by rotation of the foundation inside the horizon A (see Fig. 15 and 16). It was recognized that fluctuating water level has strong influence on the ground movement. This would lead to a potential leaning instability of the tower if a certain inclination angle is reached. The following combined countermeasures were undertaken:

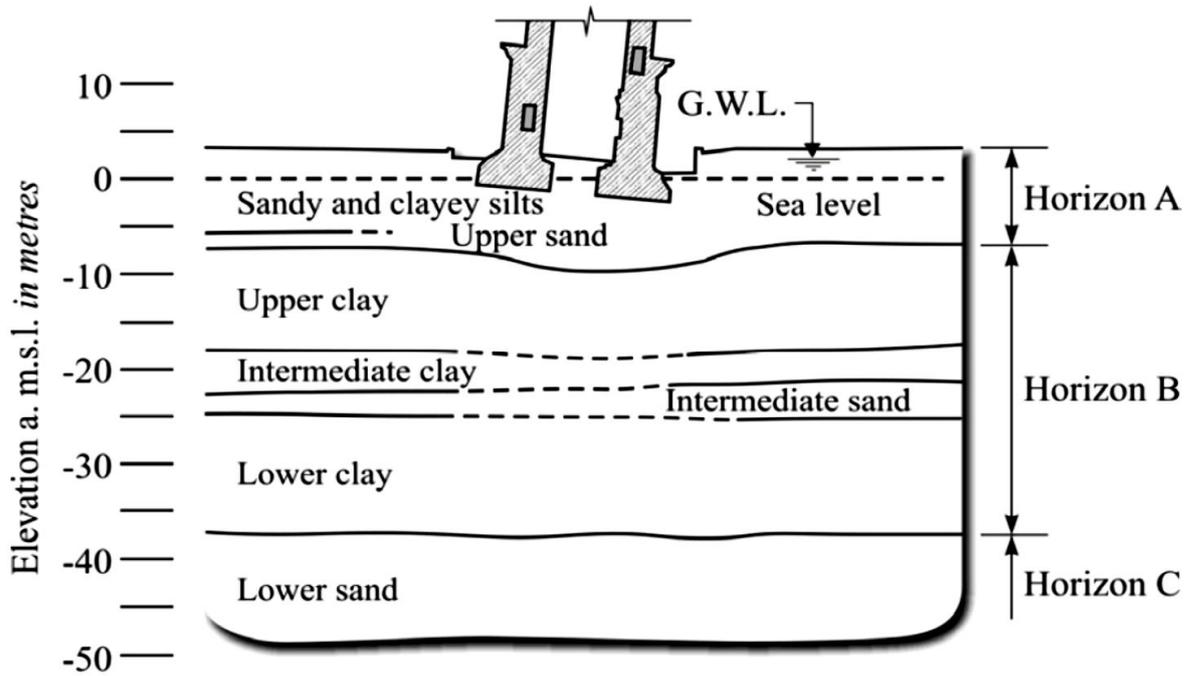
Fig. 15: Geological profile of underground and foundation area (Burland et al. 2009)

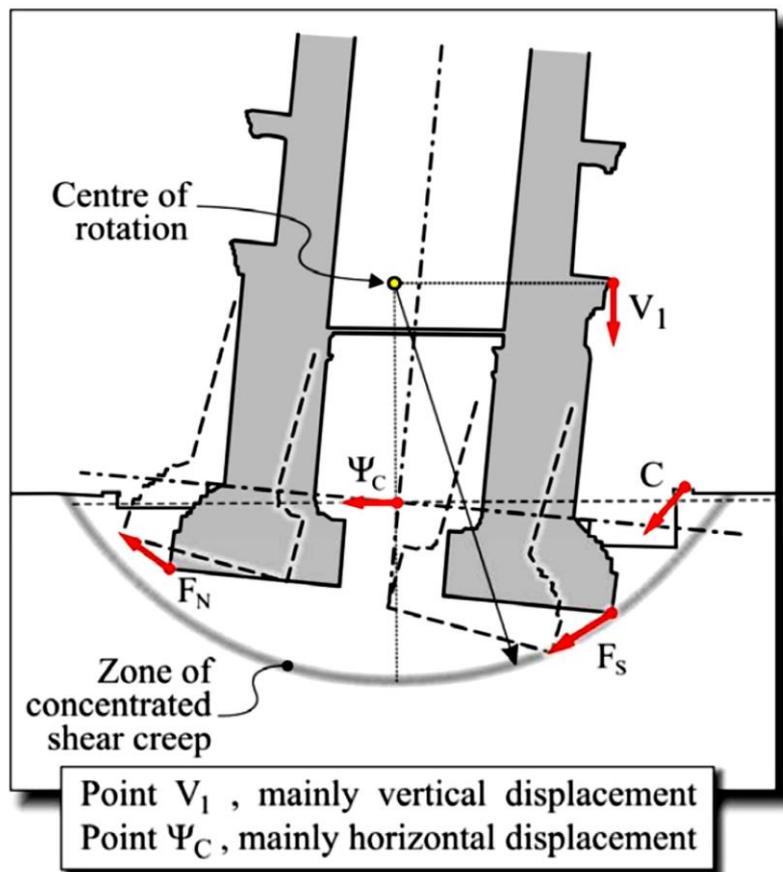
Fig. 16: Illustration of potential mechanism of ground movement (Burland et al. 2009)

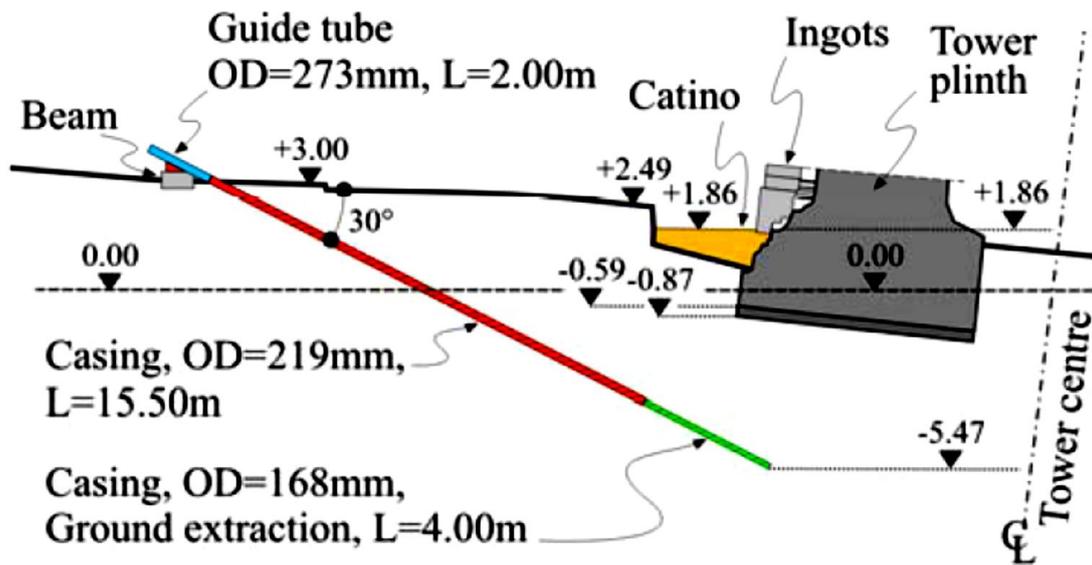
Fig. 17: Illustration of under-excitation technology (Burland et al. 2009)

- The underexcavation technique (local removal of soil via an auger) was applied to reduce the inclination of the tower. The technique is illustrated in Fig. 17.
- The ancient concrete ring was connected with the masonry foundation by stainless steel reinforcement strengthened by circumferential post-tensioning (see Fig. 18)
- A drainage system was installed to lower and stabilize the water level.

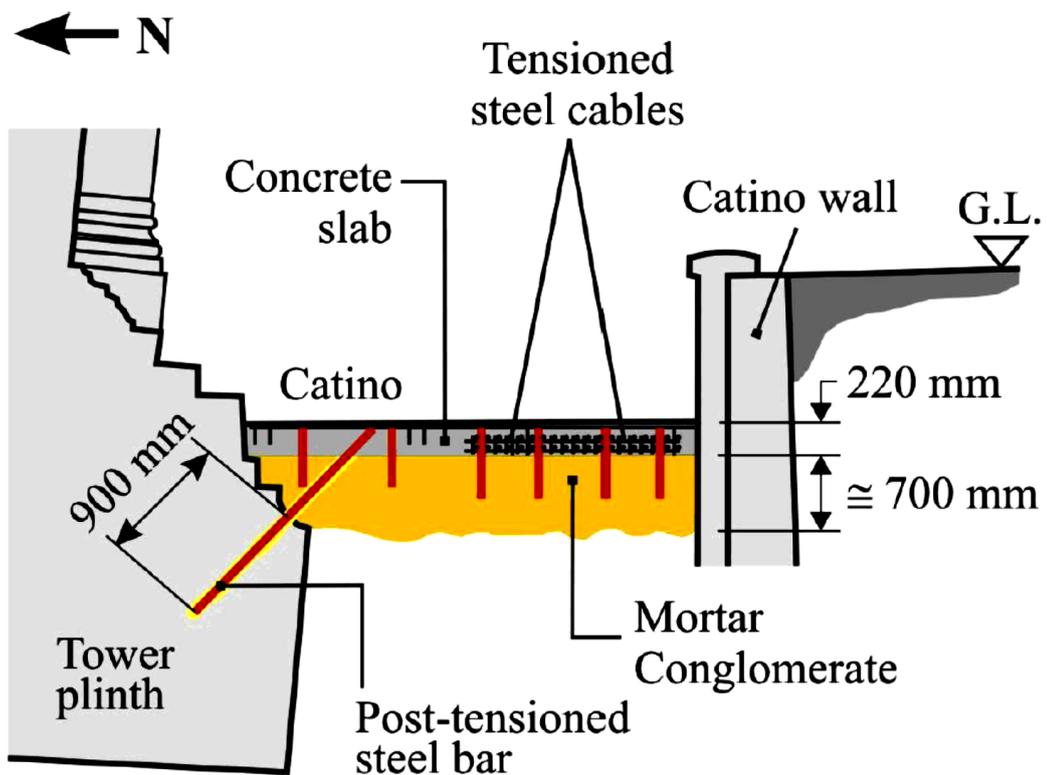
Fig. 18: Illustration of structural connection of concrete ring with tower foundation (Burland et al. 2009)
